# **ASBESTOS** **ASSESSMENT REPORT**

**20101025-2KY**

## **Kyeema**

50 Lalor Street Portland

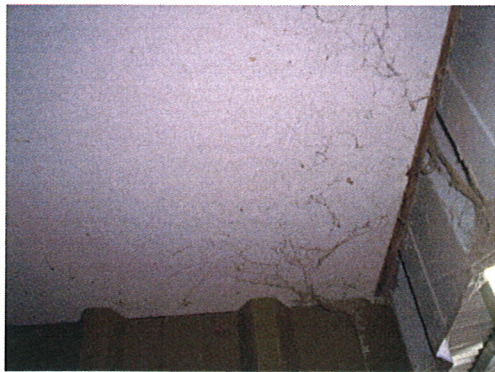
**Figure 1- Woodbox entry alcove**  
(Sample 1) Internal ceiling flat sheet  
Area: 3m<sup>2</sup>

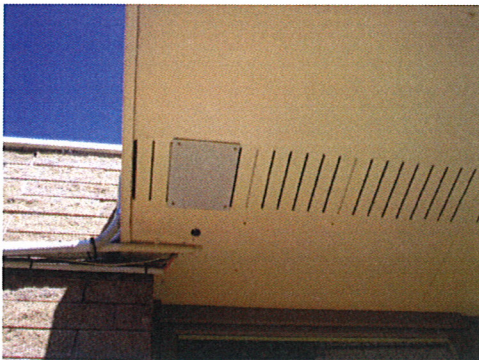
**Figure 2- Eaves**  
(Sample 2) external eaves flat sheet  
Area: 34 m<sup>2</sup>

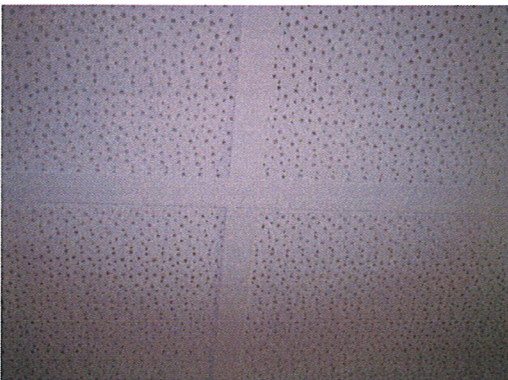
**Figure 3 -Entire internal Ceiling Area**  
(Sample 3) Ceiling Flat Sheet  
Area:

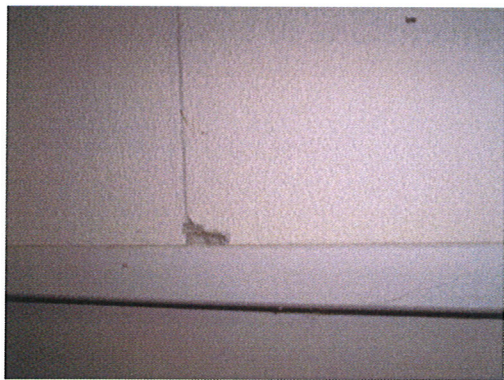
**Figure 4 – Phone Room Ceiling**  
(Sample 4) ceiling flat sheet  
Area: 12 m<sup>2</sup>

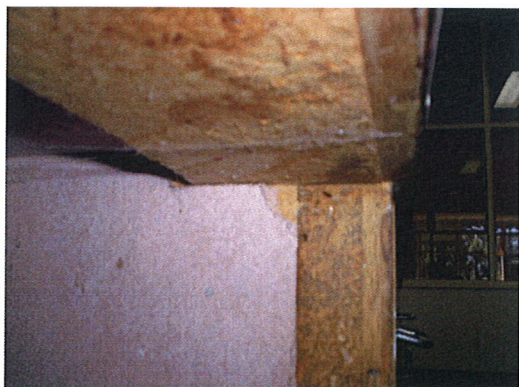
**Figure 5 – Mermaid Room under bench**  
(Sample 5) Flat Sheet  
Approx Area: 2 m<sup>2</sup>

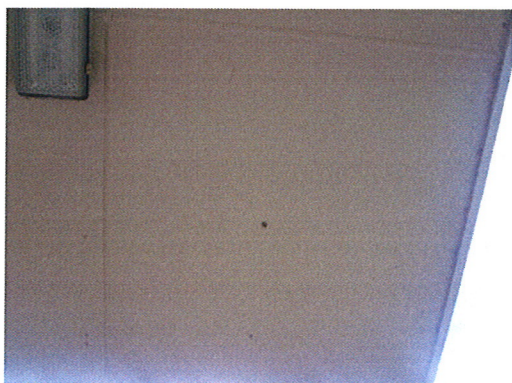
**Figure 6 – Main entry veranda**  
(Sample 6) Ceiling Flat sheet  
Approx Area: 15 m<sup>2</sup>

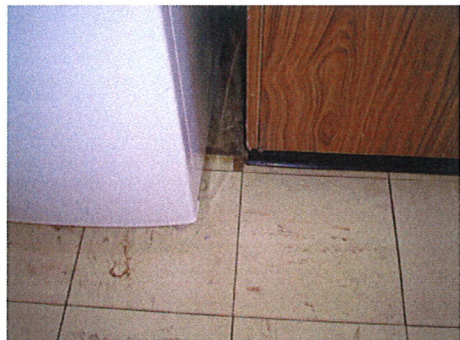
**Figure 7- Laundry/Kitchen**  
**(Sample 7)** – Floor tiles  
Approx Area 12 m<sup>2</sup>

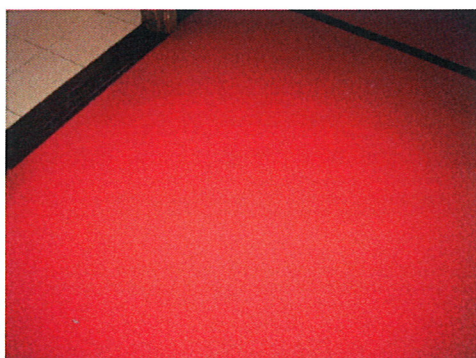
**Figure 8 – Seal room, corridor and computer room**  
**(Sample 8)** - Vinyl floor covering  
Approx Area: 166 m<sup>2</sup>

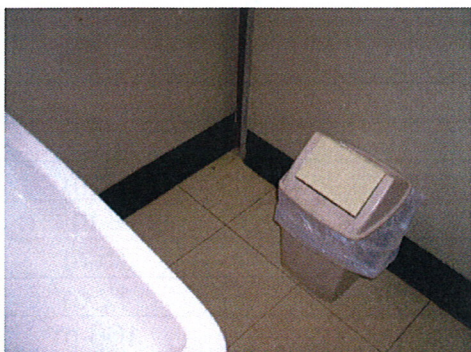
**Figure 9 – Rest room/computer room**  
**(Sample 9)** Floor tiles  
Approx Area: 3 m<sup>2</sup>

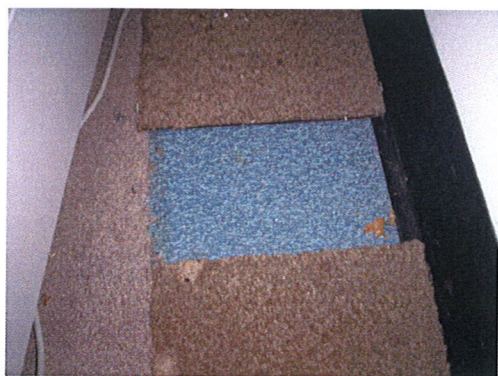
**Figure 10 – Mermaid room/staff room under carpet**  
 (Sample.10) Vinyl floor covering  
 Approx Area: 180 m<sup>2</sup>

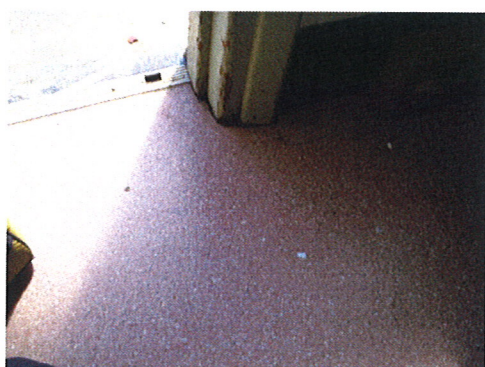
**Figure 11 – Seahorse/dolphin rooms**  
 (Sample 11) Vinyl floor covering  
 Approx Area: 200 m<sup>2</sup>
